THE FOURTH NATAN SAND DAM

Implementation Report of the sand dam between 22/10/2020 to 06/11/2020.

This report outlines the construction process/phases which was employed during the 14 days construction works of NATAN sand dam and some of recommendation to be observed in future sand dam implementation.

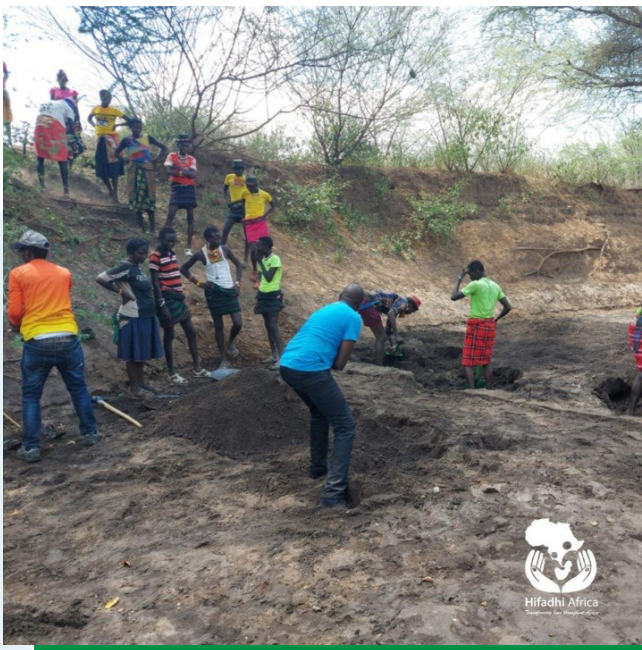
Figure 1: Pegging and marking process of the foundation trench for guidance before excavation started,

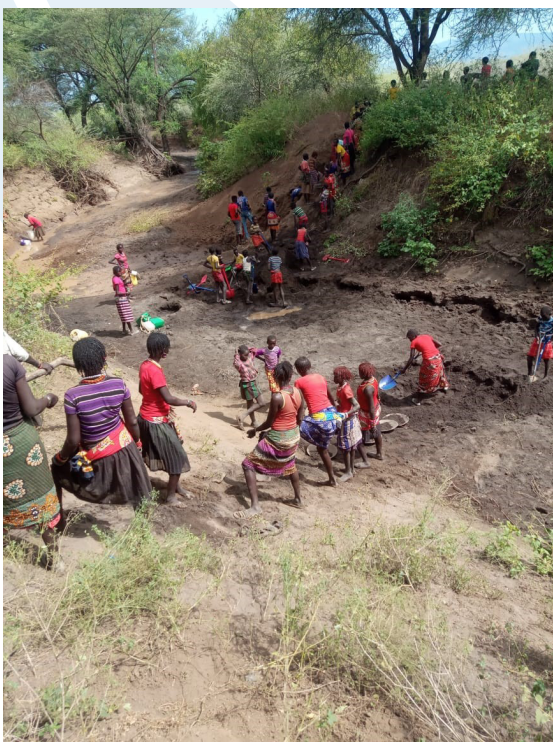
Figure 2: Sand collection done by group of women who lined up on the both side of the sand dam wings i.e. right wing and left wing concurrently.

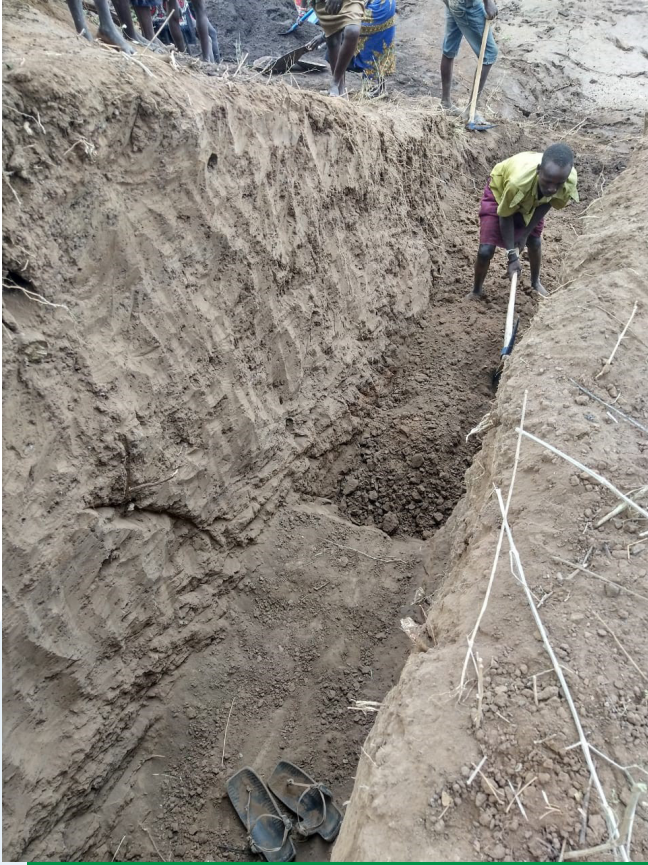
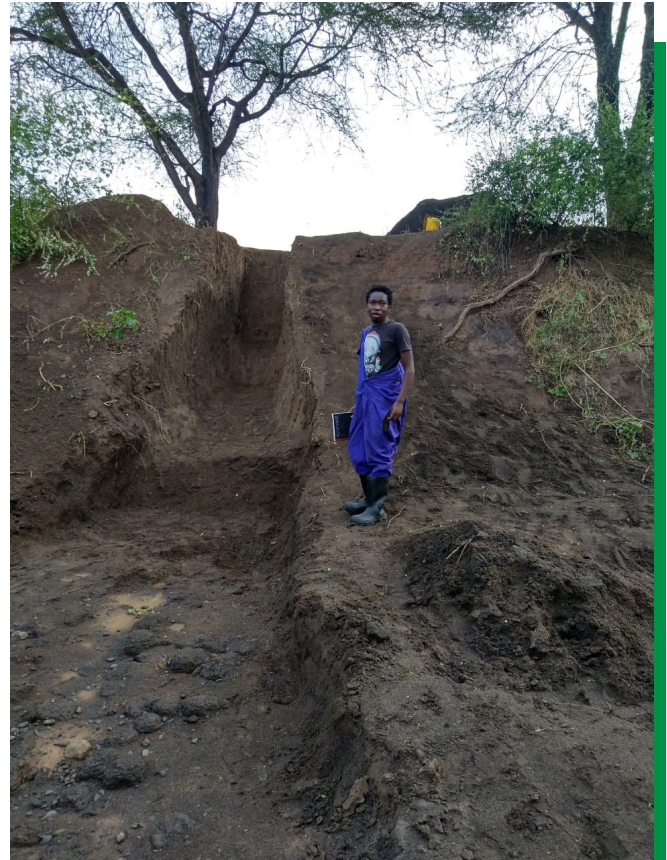
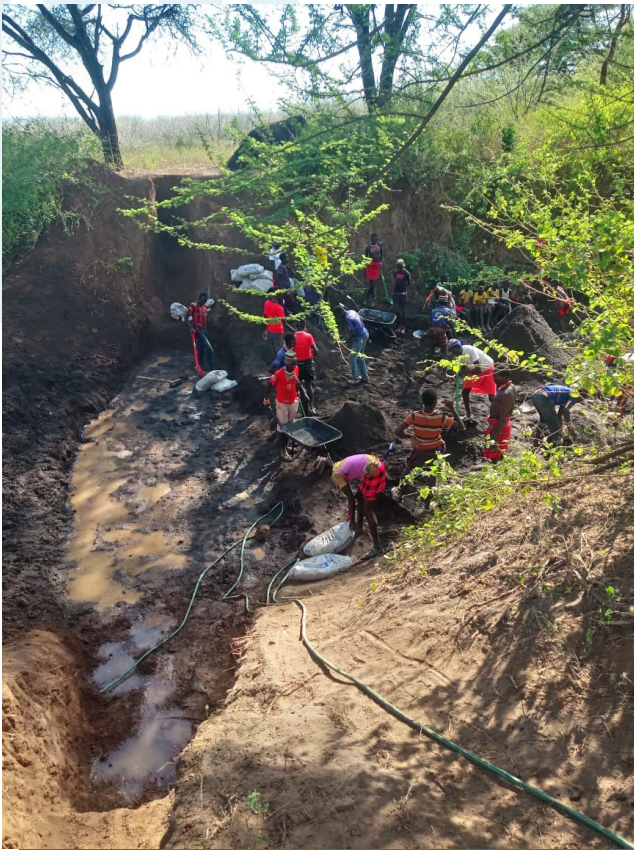
Figure 3: Excavated depth of the trench

The site was excavated up to a depth of 1m at the center of stream and 2.6m on the wing walls. Its base was 2.4m wide although the dam wall was 1.8m wide, the other 0.6m were provision for slab (Apron).

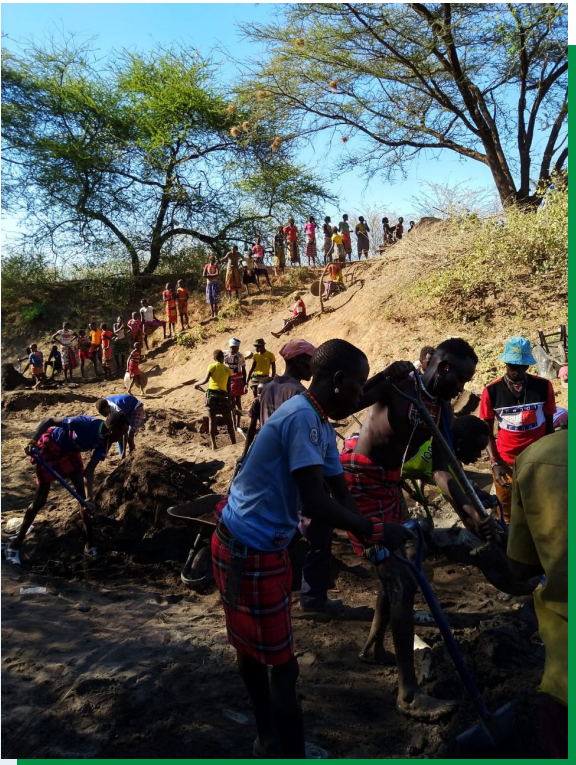
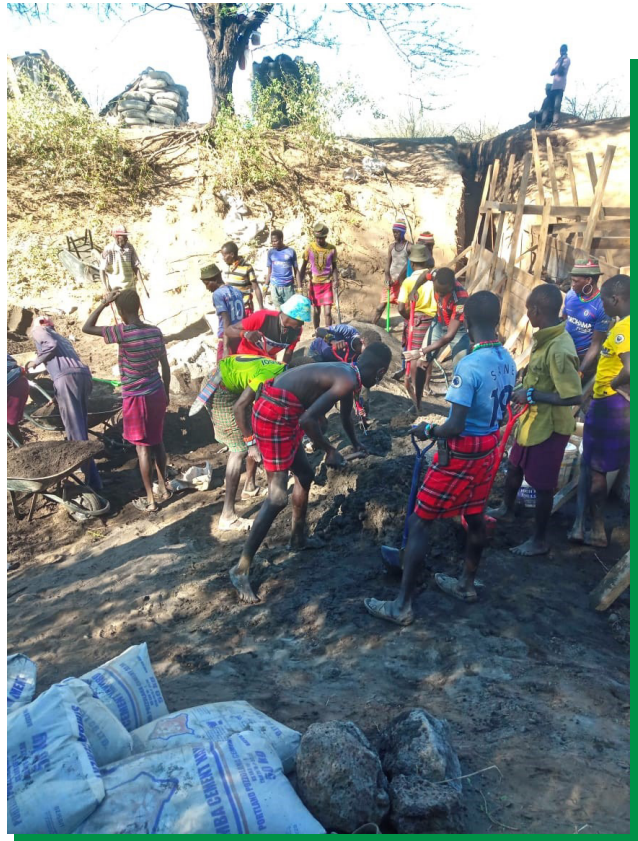
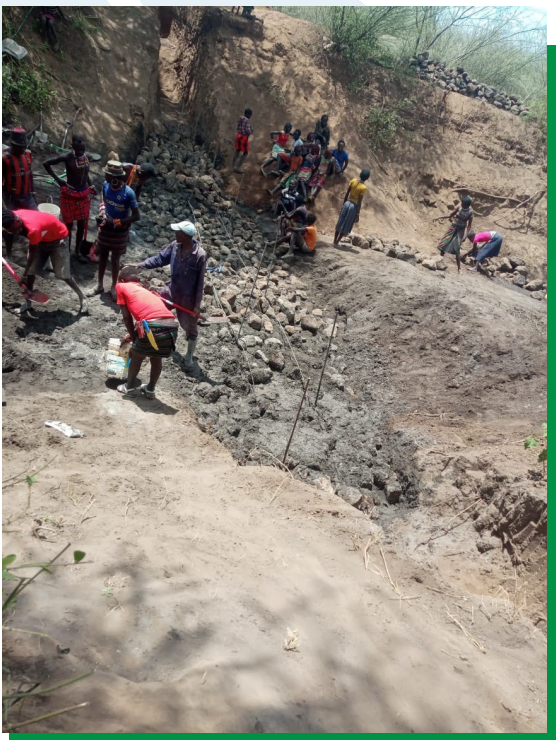
Figure 4: Community members being guided on cement mixing by UDO artisan.

A blinding of 1:2 ratios (cement:Sand) was provided on the base of the dam wall embedded on a twisted reinforced bars of Y-12 and Y-8 diameter. This was made to receive the dam weight and also used as base of sand dam wall embankment construction. Community members were guided on proper mixing of cement sand ratios 1:3 (cement:sand) which was to be used for walling and plastering.

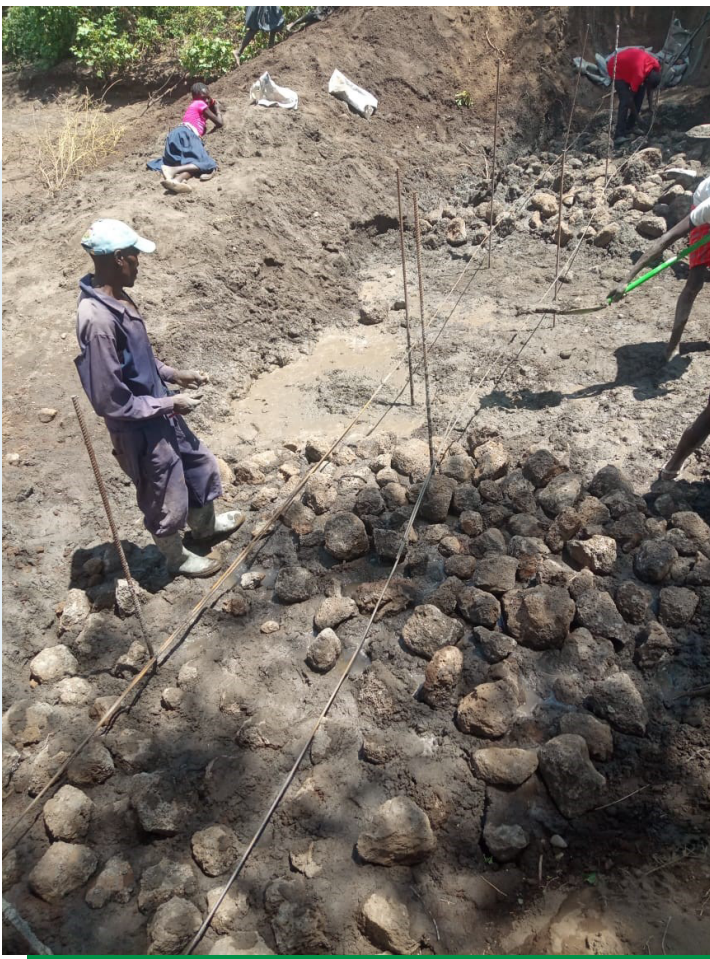
Figure 5: Portion of dam reinforced by Y-20 and Y-10 bars, barbed wire used for linkage of bars.

Reinforcement bars of twisted Y-20 and Y-10 were joined together with binding wire at intervals of 0.3 m horizontal Y10 and 1.2M for vertical bars Y20 to form both tension and compression forces, from one vertical bar to the other and of heights equivalent to the dam height crest. The Y-20 reinforcement bars were vertically set 1.2meters C-C (Centre to Centre), in the formed foundation base and at 0.5m from the sides of the timber formwork. After achieving the reinforcement, the formwork of timber and nails was provided perpendicular to the columns and firmly fixed.

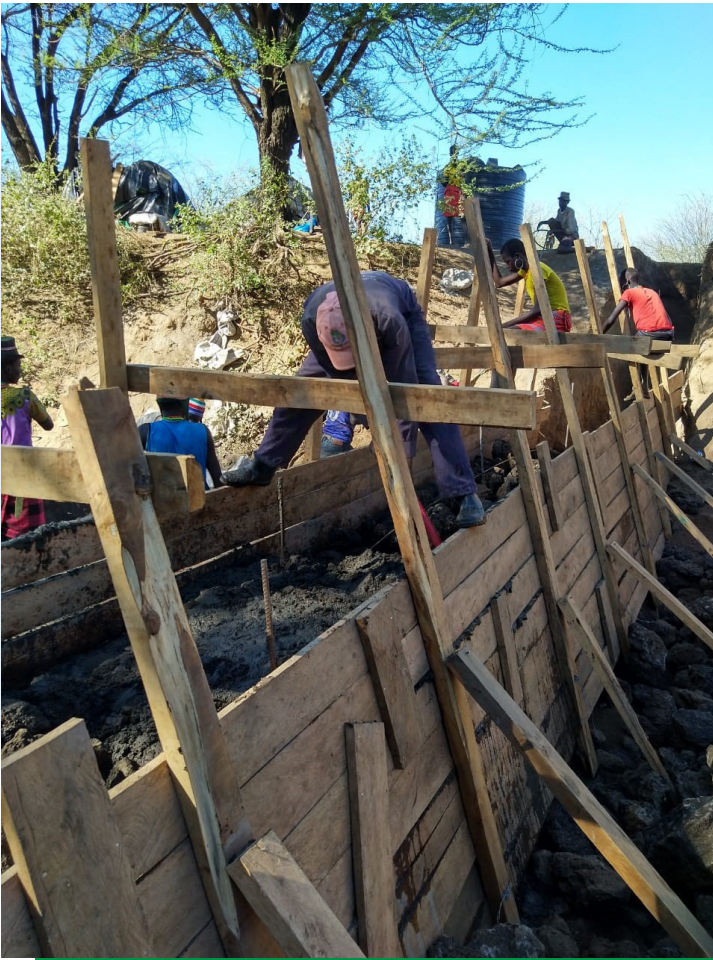
Figure 6: Placing of form work attaining the shape of the dam, just immediately after finishing the slab

Two timber forms were constructed, one for the upstream and the other for the downstream side of the dam. These formworks were used to hold the concrete mixture for a period of one day until it is hardened before removing it. The two forms were made from horizontal boards and upright timbers. The horizontal timber boards were (6 by 1)' and of several meters long. The uprights timber boards were (4 by 2)' 4m and a half meter high from the bottom to the top since our sand dam of 2.1M height from the foundation at the center of river. The horizontal timber and upright timbers were nailed together to create the form work.

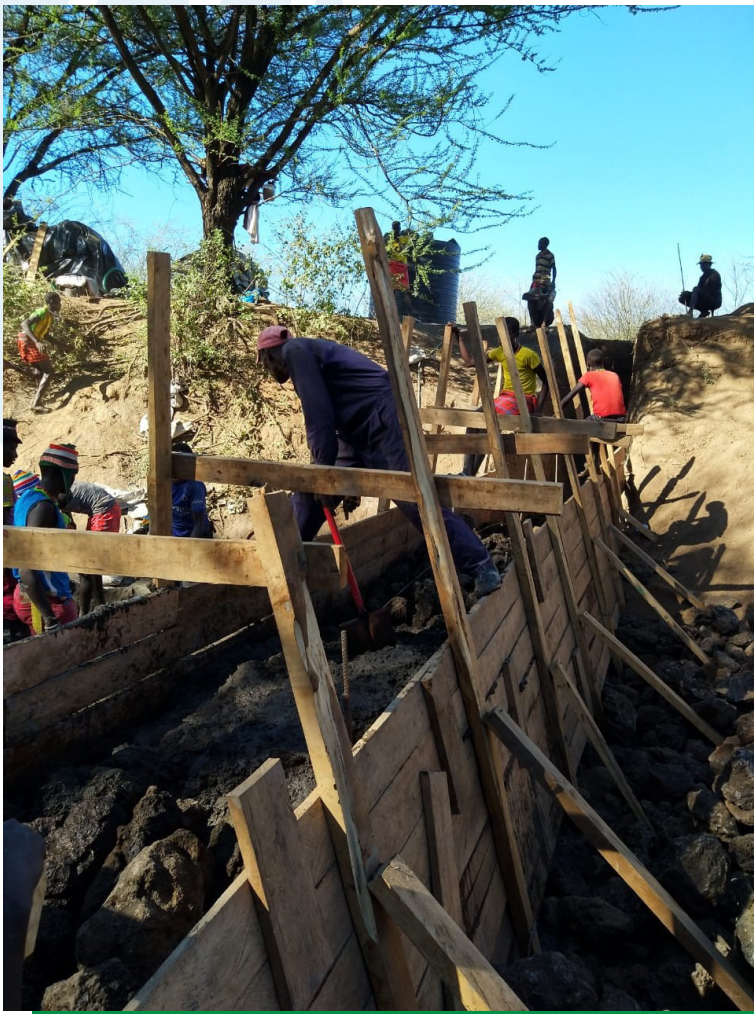
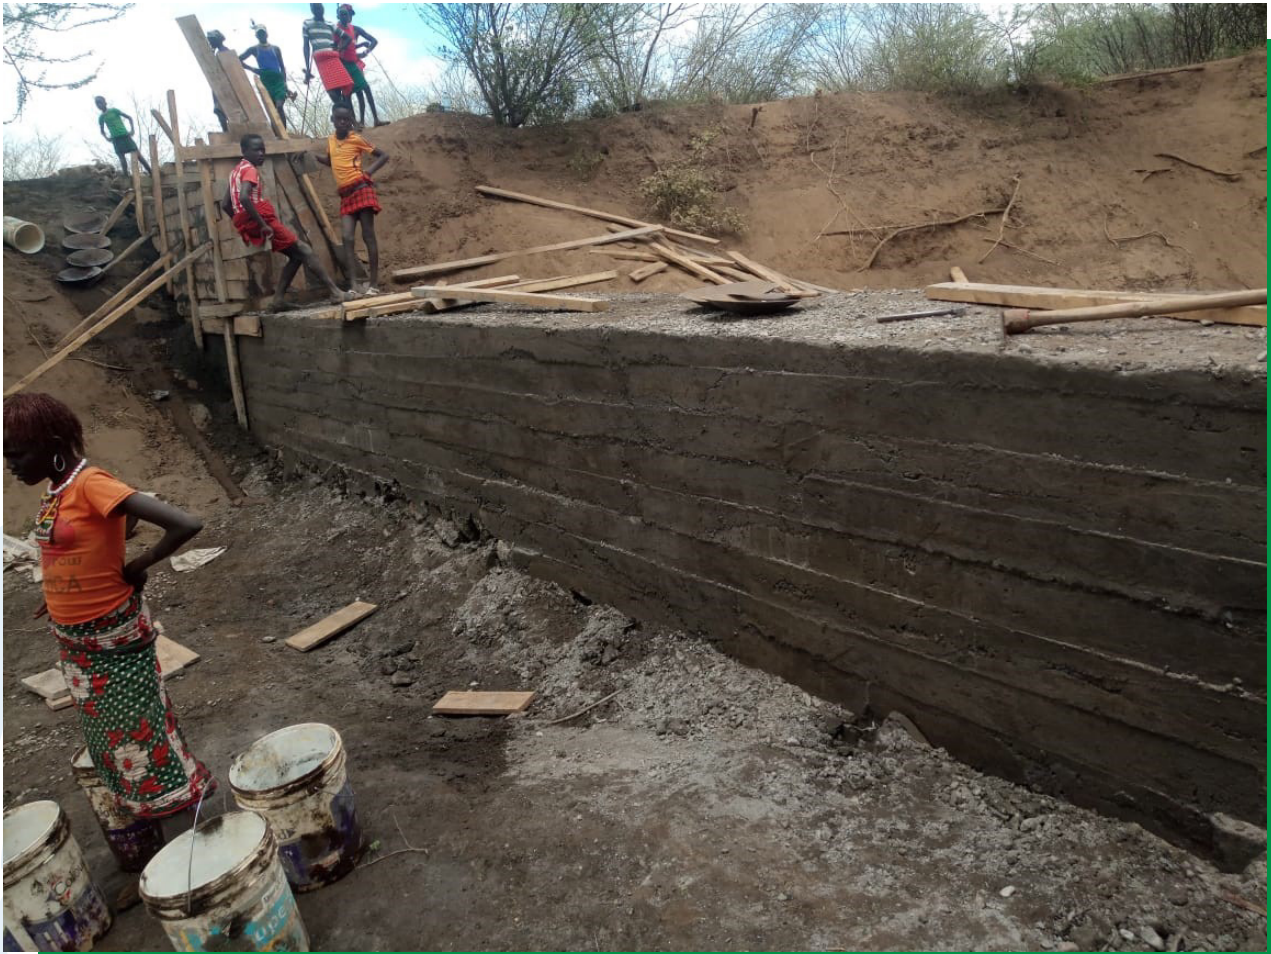
Figure 7: Interlocking of hardcore at 25mm from one to other

The form work was filled with mortar and stones under close supervision for the interlocking of the boulders. The mortar was made by mixing cement, sand and water as close to the sand dam wall as possible and with a mixed ratio of 1:3 (cement:sand) by the group members on the ground using shovels.

The stones were cleaned before they were embedded on the mortar to allow a strong bonding process. The interconnectivity was carefully made as close as 25mm from the one large flat stones, medium stones, and small stones to the other. This ratio of 1:3 was then maintained for the rest of the dam wall. Strands of reinforcement bars and barbed wire Gauge 12.5 mm diameter were placed in this mixture of mortar and stones at 0.5M intervals and repeated up to the superstructure crest. At the top of the spillway crest, a layer of 3 inch river ballast was placed to prevent the structure from eroding due to velocity of flow of storm water and rock debris. It was finally compacted to attain maximum concrete strength by removing air voids in the concrete keenly not to cause bleeding and segregation effects of concrete.

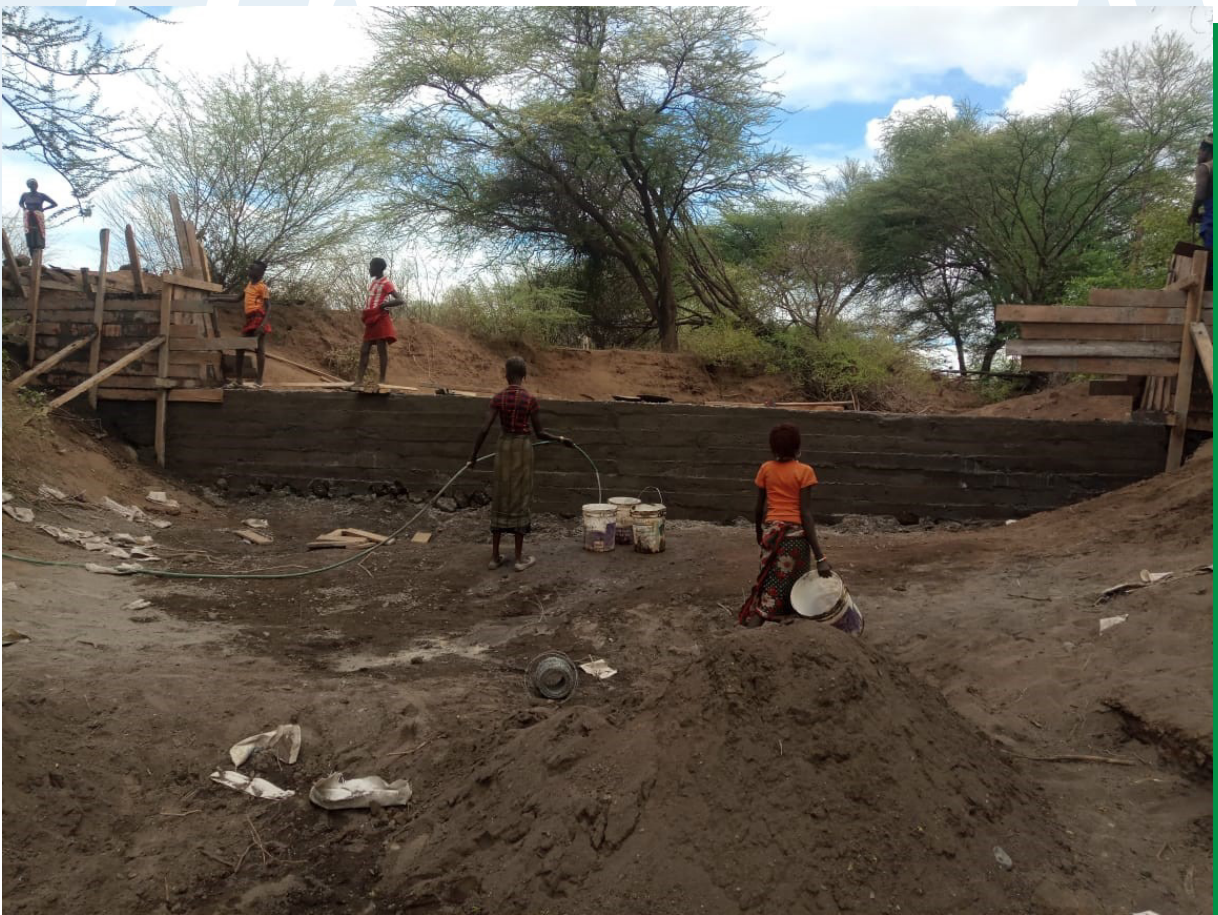
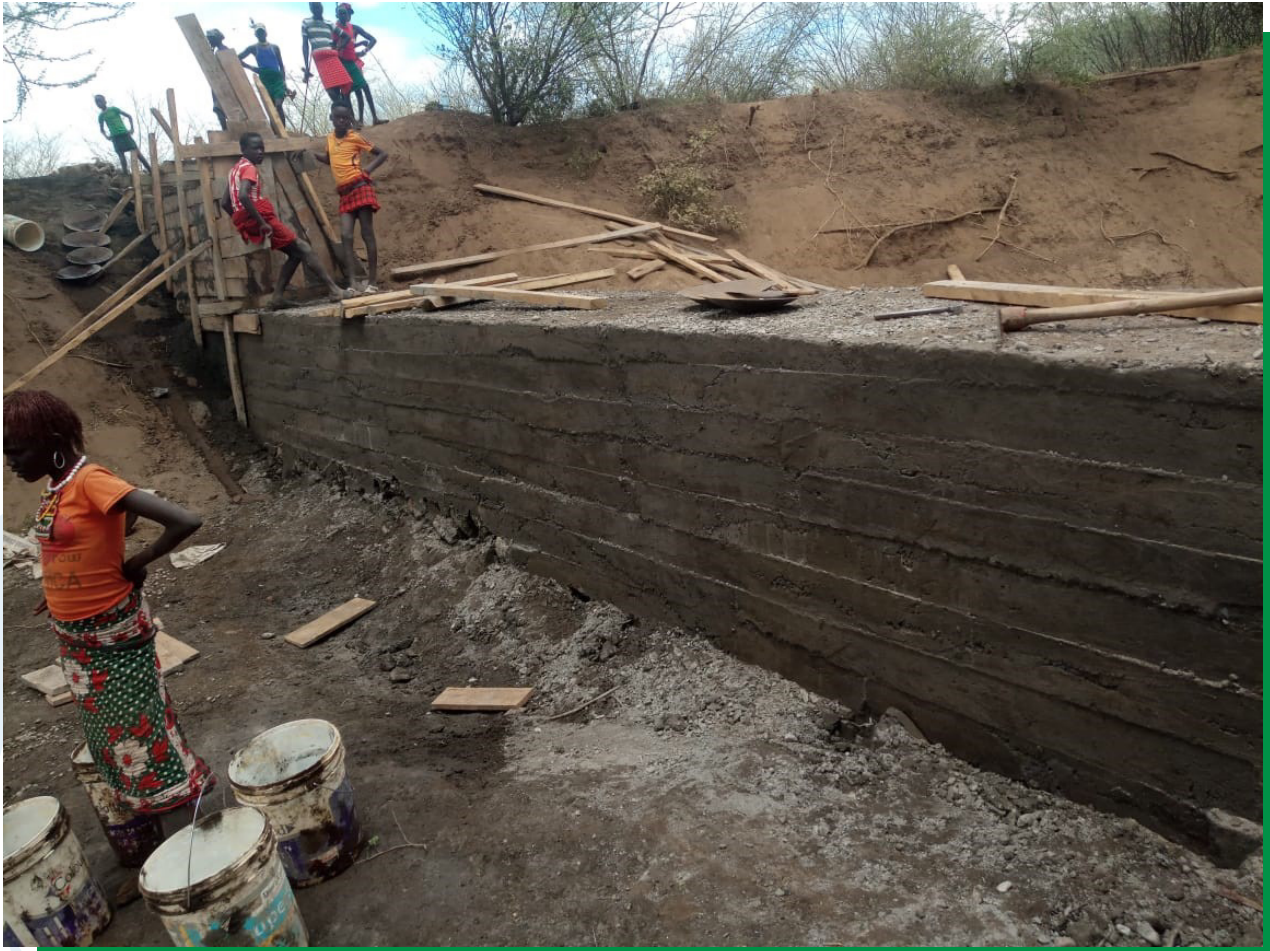
Figure 8: construction and finishing of left and right wings wall

The wing walls were built enough taking into consideration the riverbanks levels of both sides and extended on sideways left bank and right bank 6.3M and 4.7M respectively. They are made to keep the flood waters from going around the sand dam and causing erosion and eventual undercutting of the dam walls. One of the greatest geographical advantages of the sand dam site has been very firm bed rock where the foundation started; this increases the strength of the wing walls, thus resistance against overturning and sliding effects.

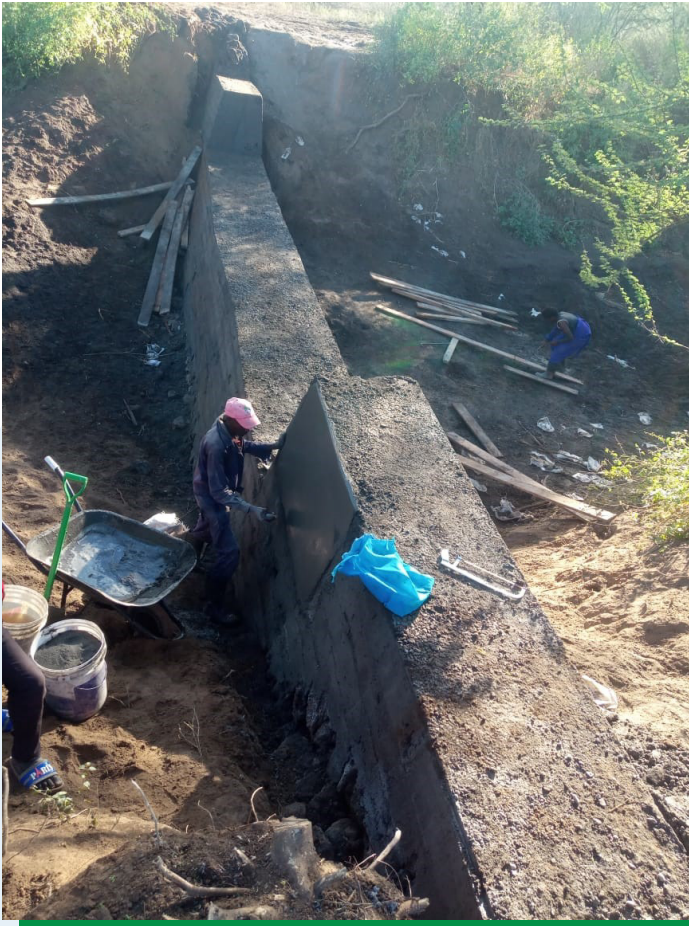
Figure 9: Inscription of partners and donors names on the dam walls
