Rescue project of the Parque Arqueológico
El Caño museum

Fundación El Caño
2017

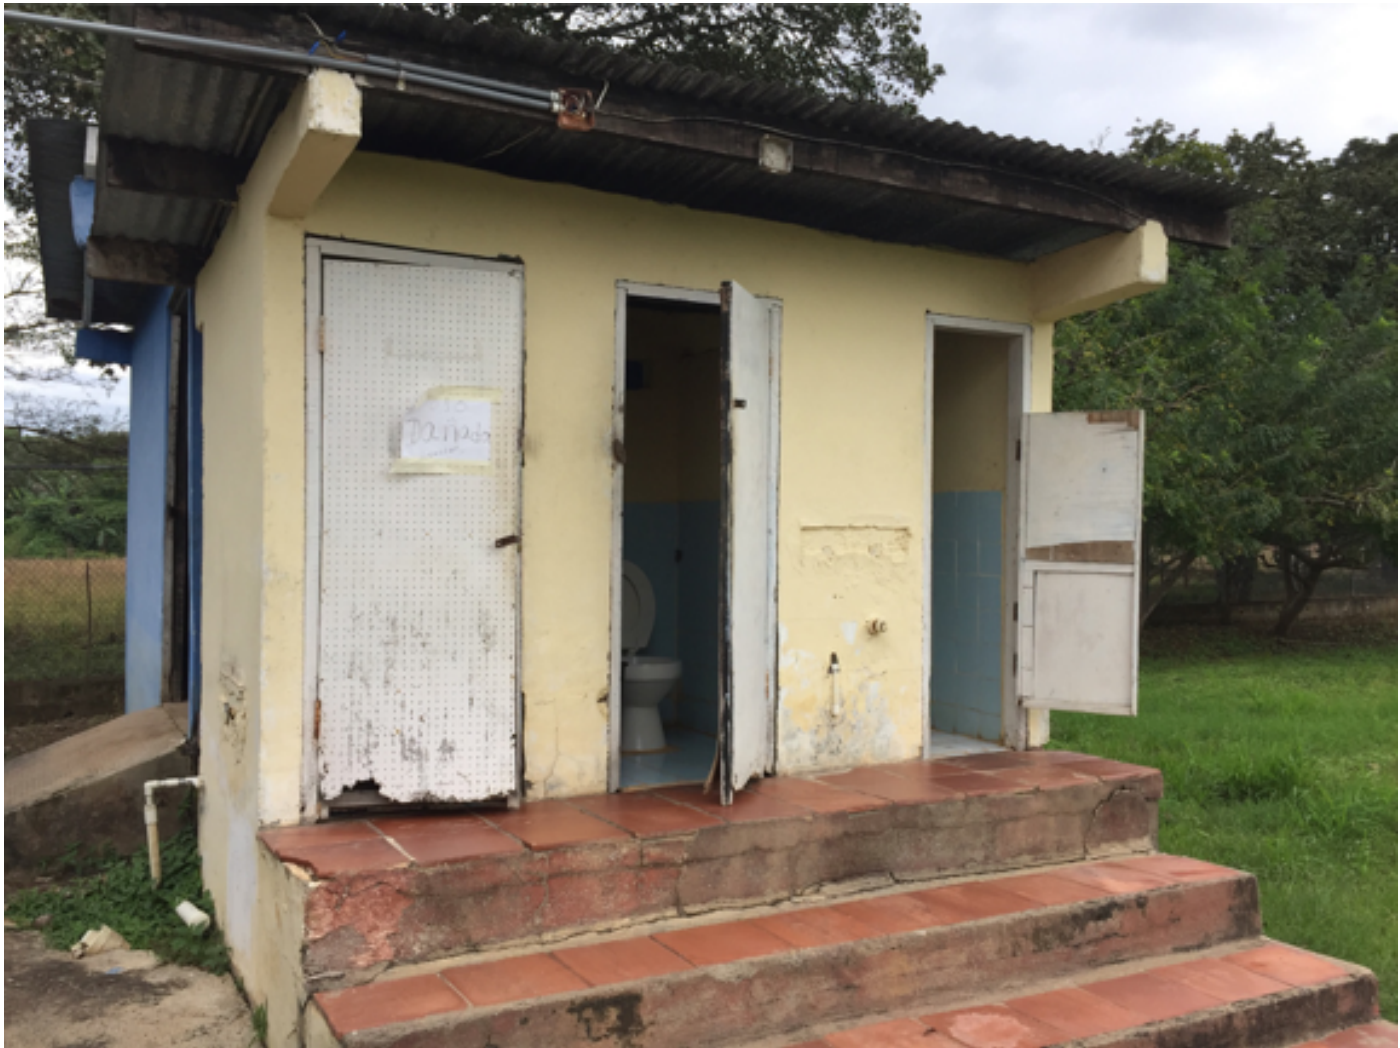
The bathrooms of the museum today

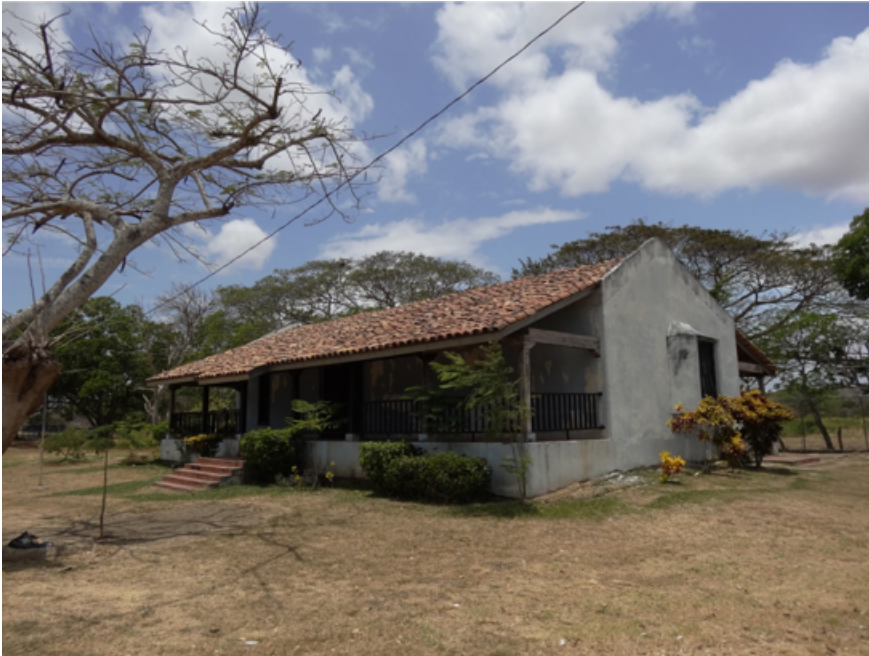
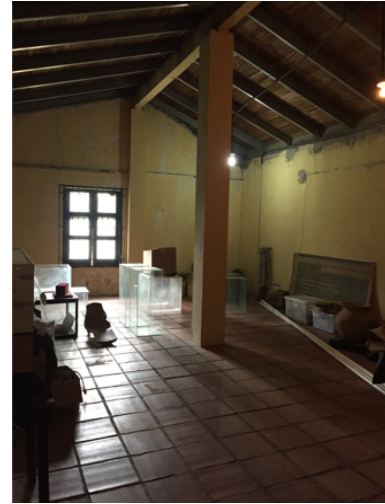
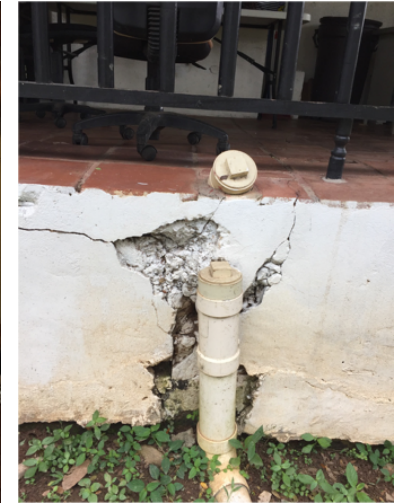
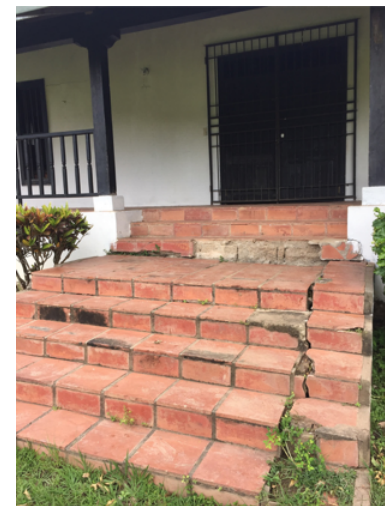
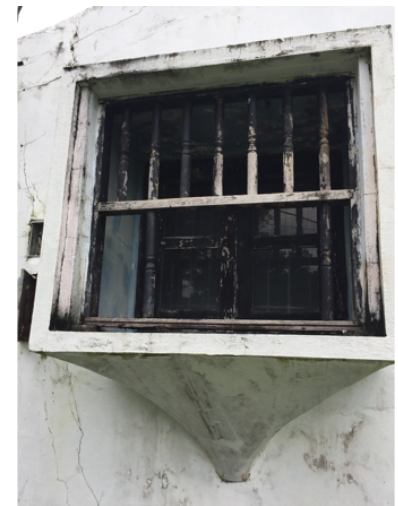
Component 3. Renovating the house-museum. Current state of the building

The house-museum of El Caño was built by archaeologist Reina Torres de Arauz in 1979. It has two offices and an exhibition room. These three units communicate through an anteroom.

- 1.- Fixing of filtrations in the west and east wall. When placing the new roof, the high sections of the north and south walls were left with untreated concrete. Rainwater filters through the concrete. The paint will be removed from the entire wall with a water injection machine. Afterwards elastomeric putty and sealer and concentrated acrylic base will be used.

- 2.- Tile repair in the main staircase and the north corridor. To do this, tiles of the same model in storage will be used. The museum has 200 tiles in stock. The old ones will be raised, the floor will be filled (the reason why the tiles were broken is that the filling on which the museum rests has lost density and volume) and, once leveled, the new tiles will be placed. On them will be tinted color tile to recover the color lost over the years.

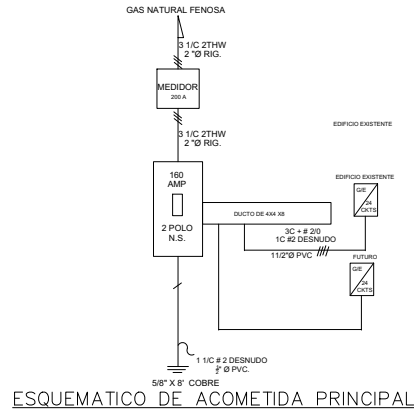
ESQUEMATICO DE ACOMETIDA PRINCIPAL

CARGA A INSTALAR.....	41,000 VA (220.83AMP)
CARGA DE RESERVA.....	45,500 VA (189.58AMP)
CARGA TOTAL.....	98,500 VA (410.41MP)
FACTOR DE DEMANDA.....	0.80
CARGA DEMANDADA.....	78,800 VA.
CONDUCTOR DE ENTRADA.....	3 1/2\"/>
TUBERIA DE ENTRADA.....	1T-4\"/>
RECEPTACULO DE ENTRADA.....	BASE A PATRON
INTERRUPTOR PRINCIPAL.....	400 AMP 2 POLOS.
BARRA DE GROUN.....	3/4\"/>
PANEL DE DISTRIBUCCION G/E.....	16 Y 12 CKTOS
SALIDAS DE CARGA.....	1 POLO (55) - 2POLO (4)
